KENNEWICK, WASHINGTON

COLUMBIA VALLEY CENTER FOR RECOVERY

1.4 Existing Conditions Observations and Reports

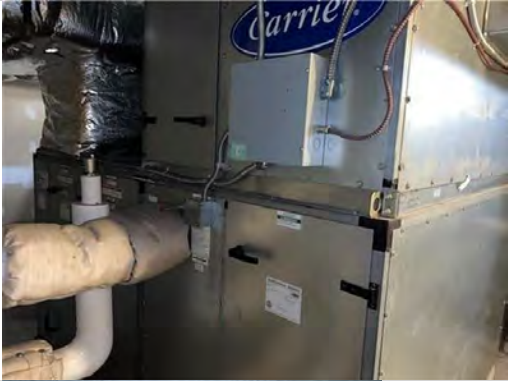
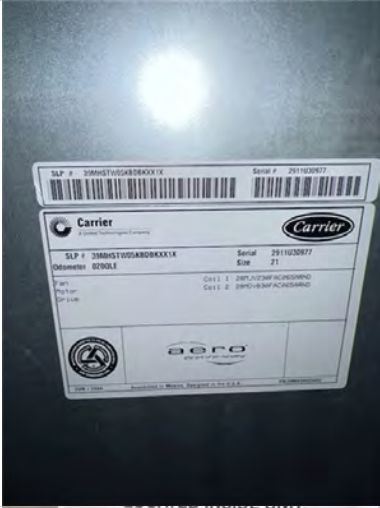
Unit	Description	Picture
AHU-01	<p>Unit age is 10 years.</p> <p>System Condition: Fair</p>

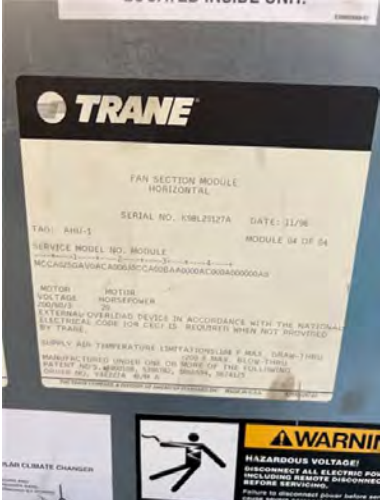
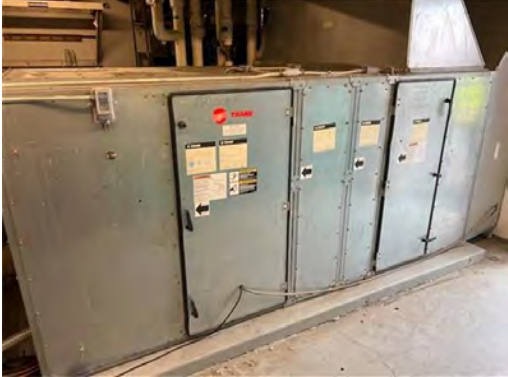
Unit	Description	Picture
AHU-04

AHU-04	<p>System age is 17 years. This is nearing the end of the useful life expectancy of 20 years.</p> <p>System Condition: Poor</p>

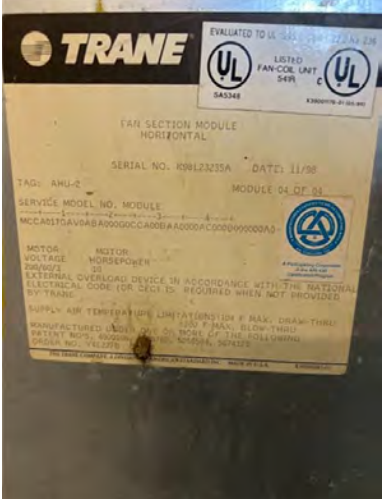
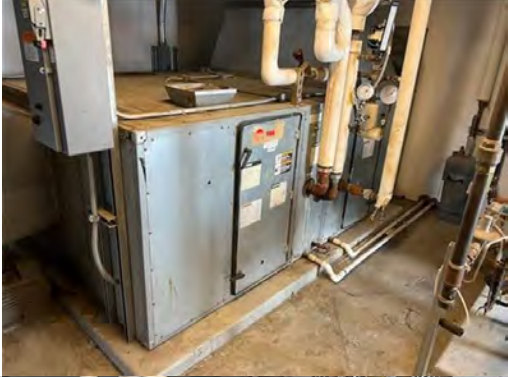
AHU-05	<p>System age is 22 years. This exceeds useful life expectancy of 20 years.</p> <p>System Condition: Poor</p>

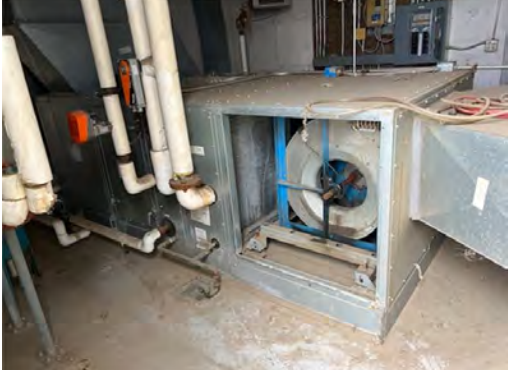
AHU-06	<p>System age is 17 years. This is nearing the end of the useful life expectancy of 20 years.</p> <p>System Condition: Poor</p>

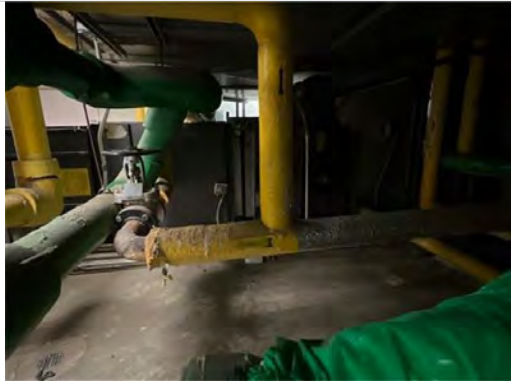
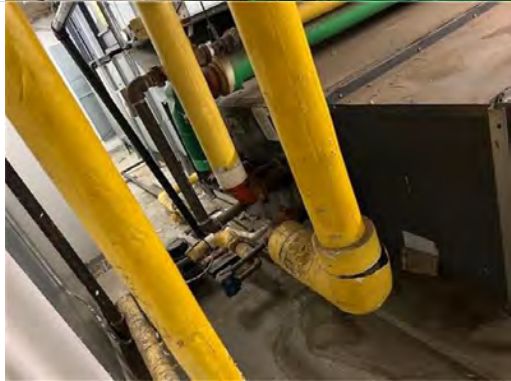
Unit	Description	Picture
AHU-06		
AHU-06		
AHU-09	<p>System age is 33 years. This exceeds useful life expectancy of 20 years.</p> <p>System Condition: Poor</p>

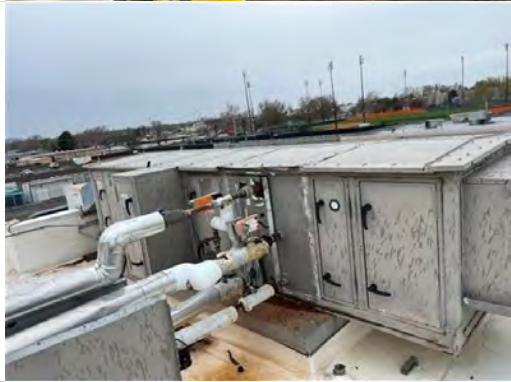
AH-10	<p>System age is 16 years. This is nearing the end of the useful life expectancy of 20 years.</p> <p>System Condition: Poor</p>

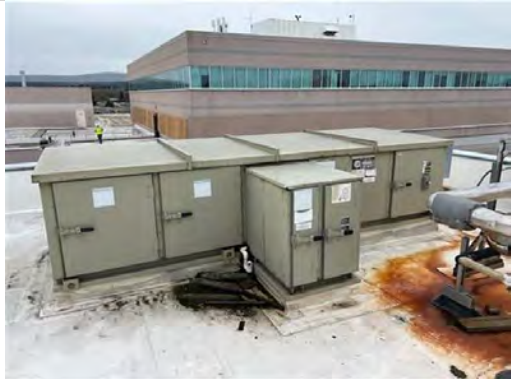
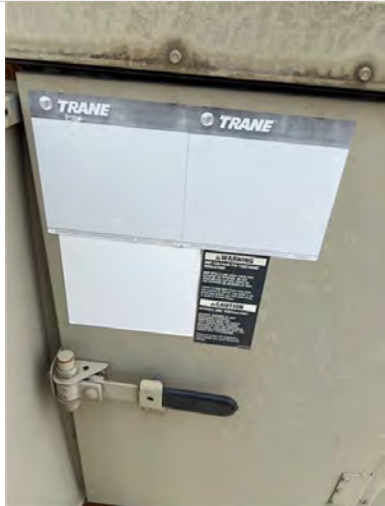
Unit	Description	Picture
AHU-11

AHU-11	<p>System age is 17 years. This is nearing the end of the useful life expectancy of 20 years.</p> <p>System Condition: Poor</p>

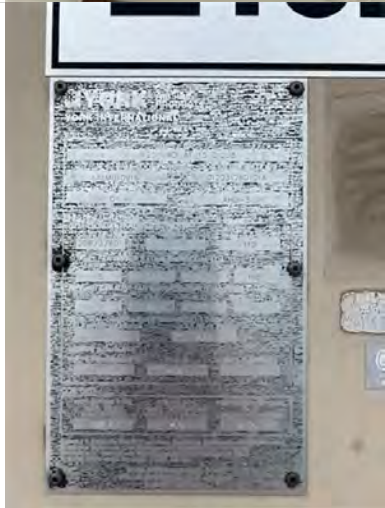
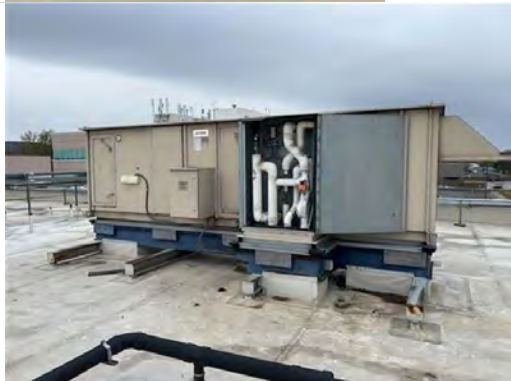
AHU-12	<p>System age is 20 years. This is right at the useful life expectancy of 20 years.</p> <p>System Condition: Poor</p>

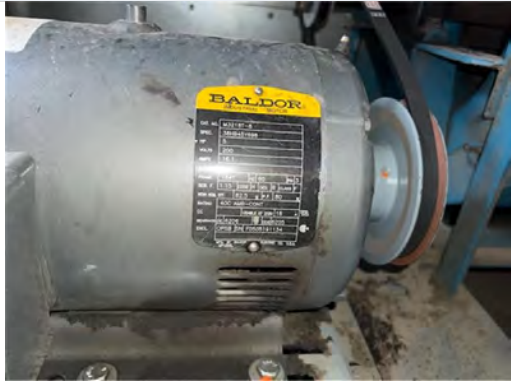
Unit	Description	Picture
AHU-13	<p>System age is 16 years. This is nearing the end of the useful life expectancy of 20 years.</p> <p>System Condition: Poor</p>

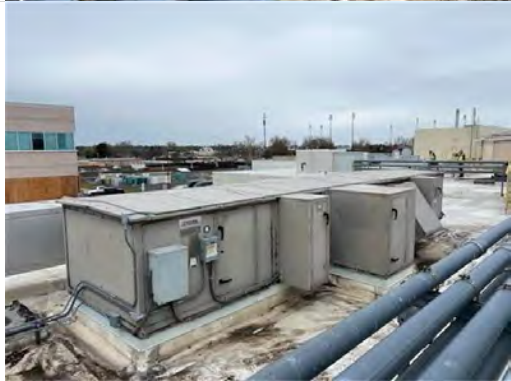
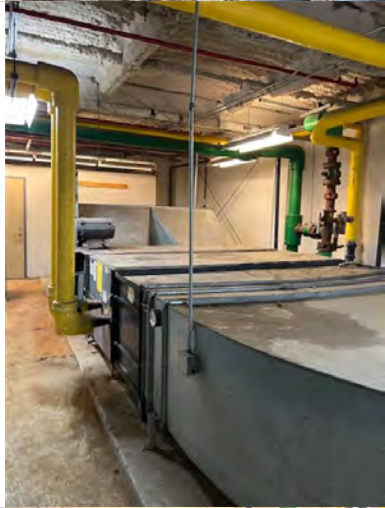
AHU-14	<p>System age is 33 years. This exceeds useful life expectancy of 20 years.</p> <p>System Condition: Poor</p>

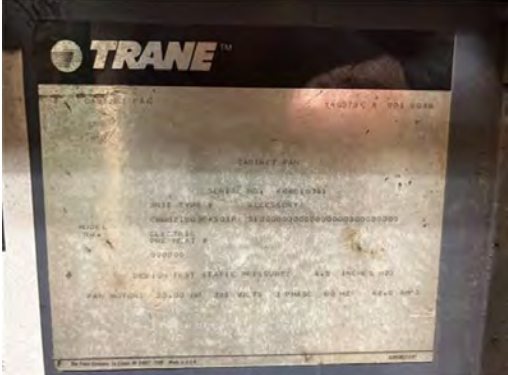
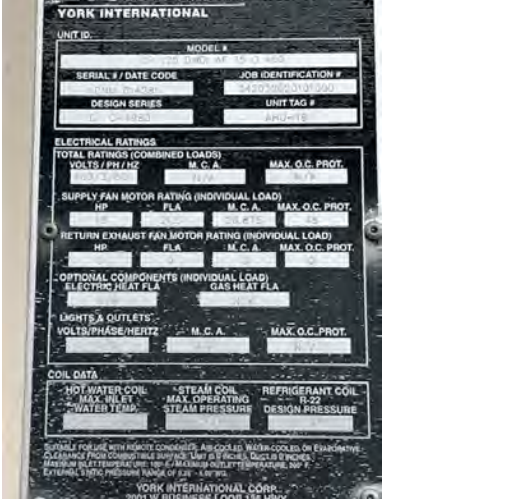
AHU-15	<p>System age is 17 years. This is nearing the end of the useful life expectancy of 20 years.</p> <p>System Condition: Poor</p>

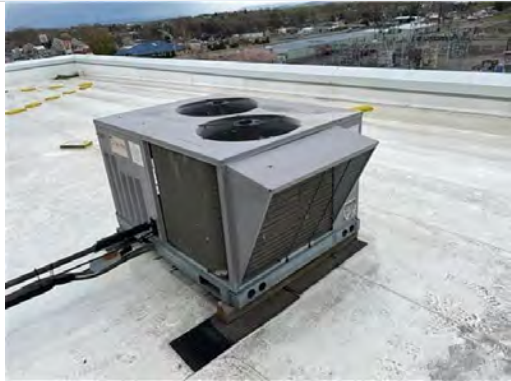
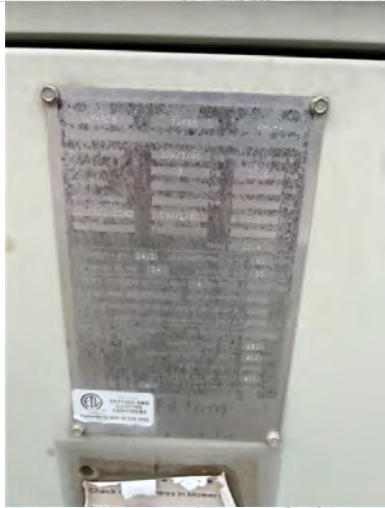
AHU-U2	<p>System age is ?? years.</p> <p>Useful Life Expectancy: 20 years</p> <p>System Condition: Poor</p>

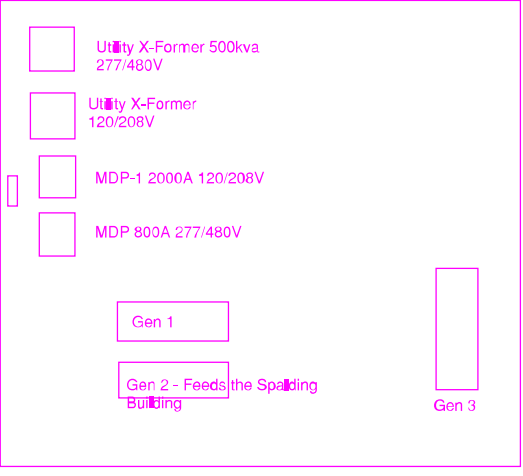
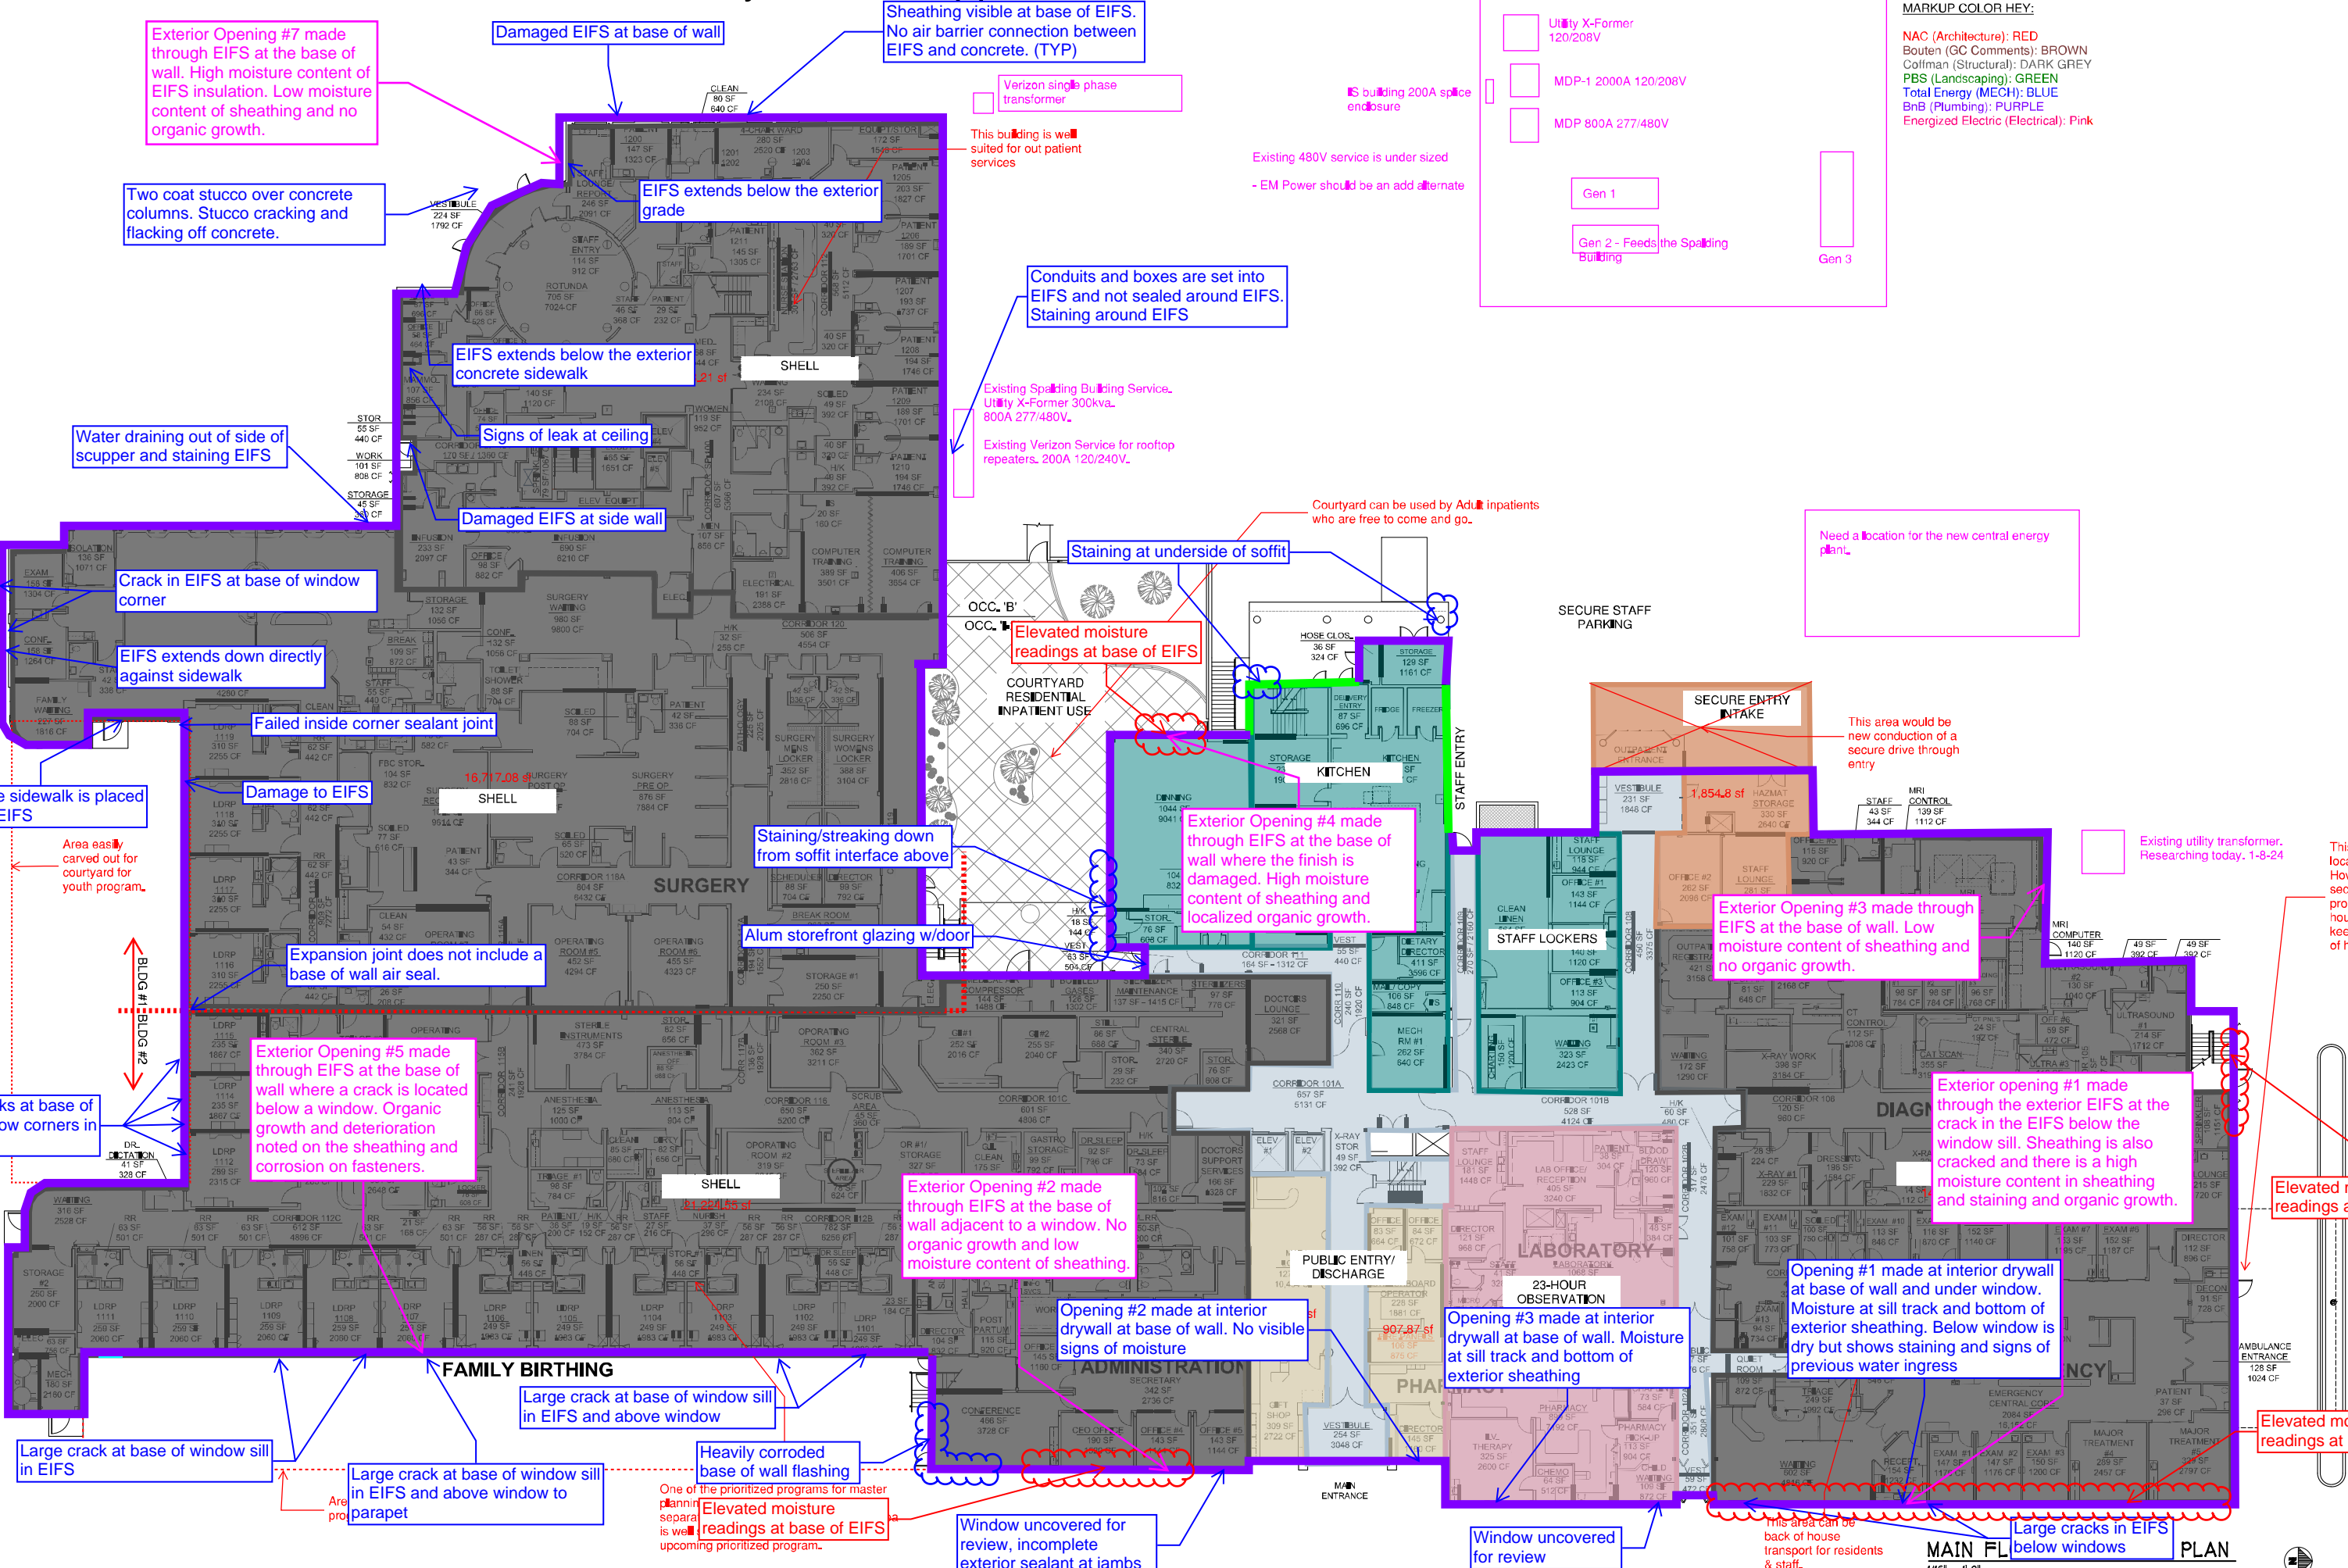
Exterior Opening #7 made through EIFS at the base of wall. High moisture content of EIFS insulation. Low moisture content of sheathing and no organic growth.

Damaged EIFS at base of wall

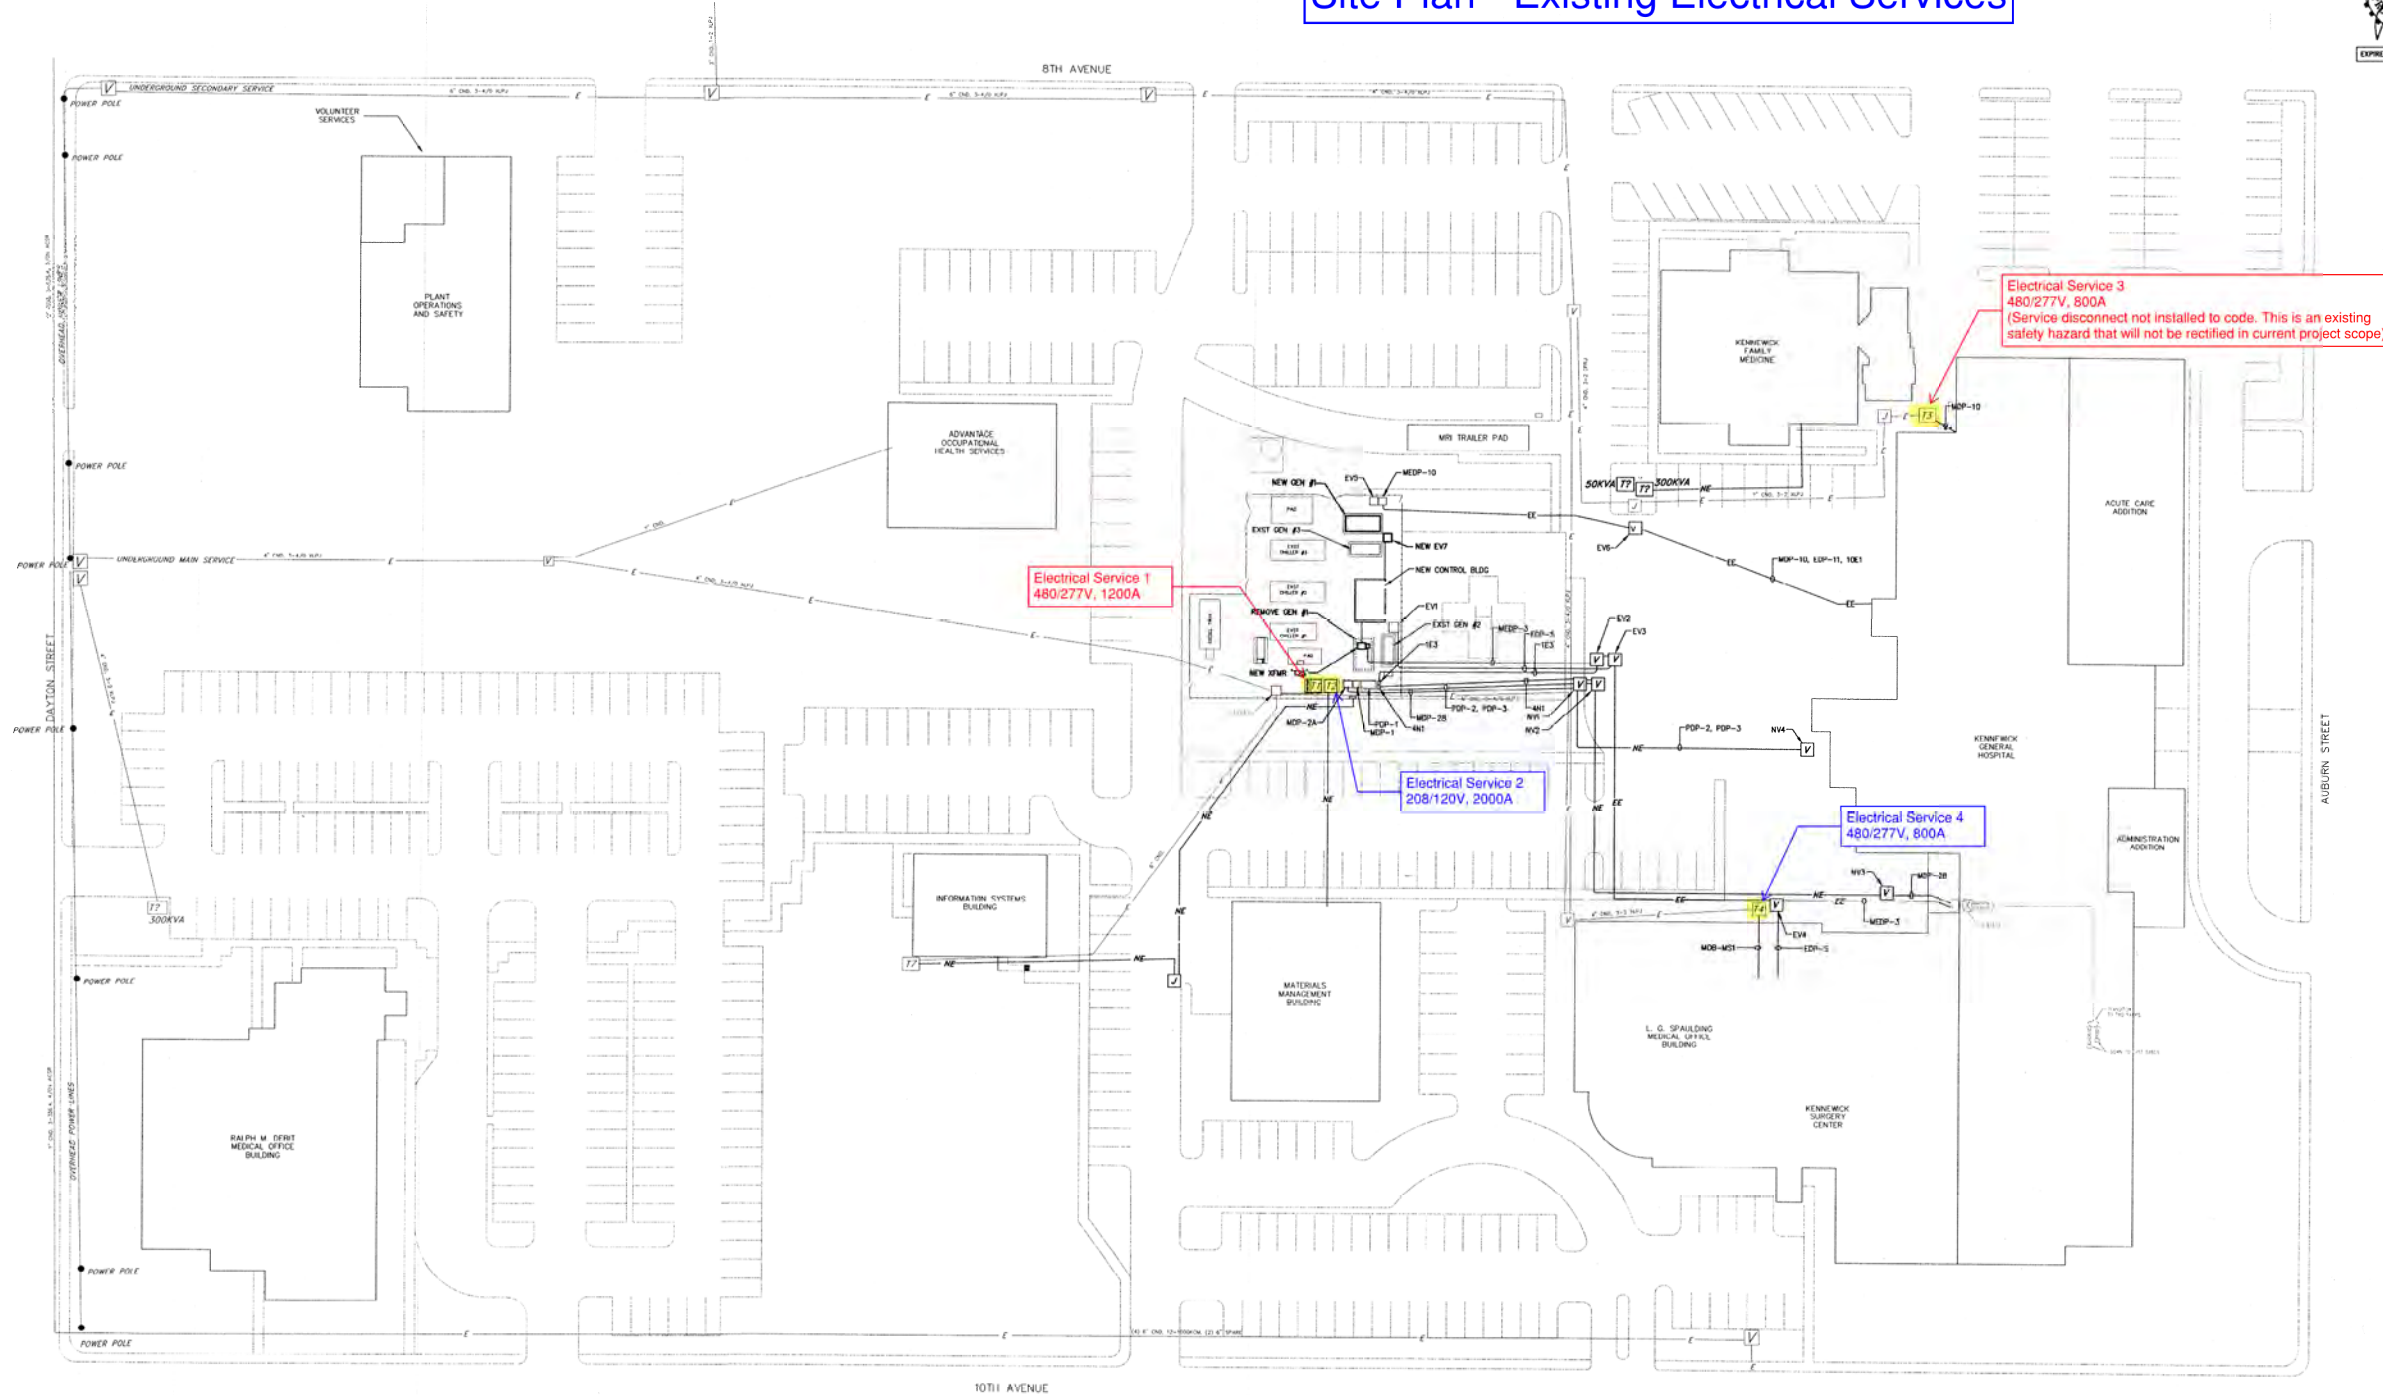
Electrical Service 3
 480/277V, 800A
 (Service disconnect not installed to code. This is an existing safety hazard that will not be rectified in current project scope)
