KENNEWICK, WASHINGTON

COLUMBIA VALLEY CENTER FOR RECOVERY

1.4 Existing Conditions Observations and Reports

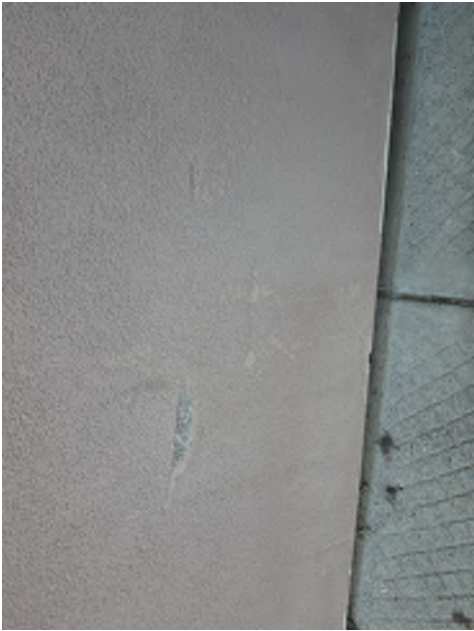
Photo 01

We noted small but widespread cracking of the lamina throughout the areas we reviewed, most commonly originating from corners of windows and at the base of wall where the EIFS extends down to meet the exterior sidewalk (see Photos 01 through 09). We also noted several locations with significant cracks ranging from 1/16" to ¼" as well multiple

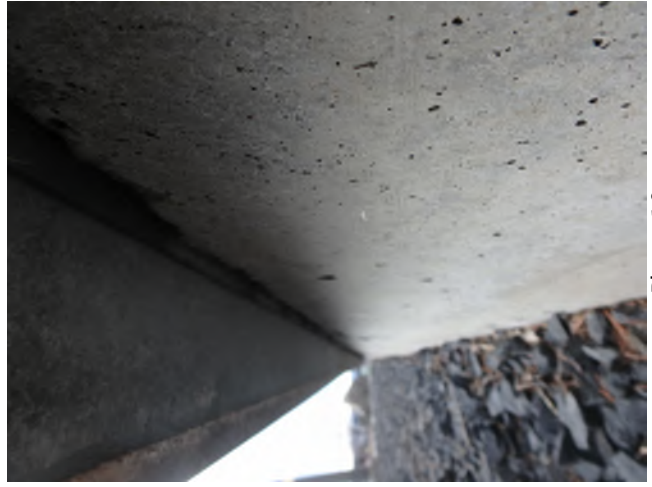
Photo 10

- Gypsum sheathing is visible at the underside of the EIFS system at several locations at the exterior of the building (see Photo 10). This indicates a potential gap in the building's air barrier at these locations.
- The majority of the EIFS walls are capped with metal flashings, however some small discrete coping areas are formed by the EIFS itself, and these exhibit more concentrated signs of damage. These areas are showing organic growth, damage, and significant cracking (see Photo 70)
- At the EIFS coping at the top of the ICU mechanical penthouse the outer layer of lamina has failed and the reinforcing mesh is visible at many locations.
- EIFS cladding adjacent to the entry sloped glazing exhibits moisture staining and signs of water saturation (see Photos 47, 48 and 51).

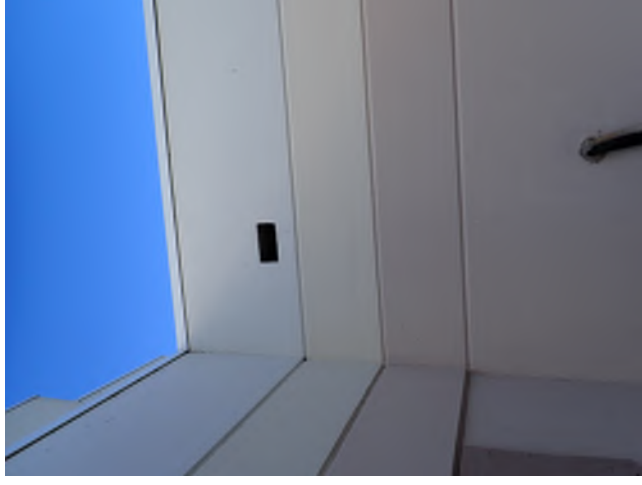
Photo 25

The original hospital walls are painted concrete with a framed interior-insulated furring wall. The paint appears aged and is exhibiting cracking and flaking in several areas. There are also two locations with large cracks in the concrete with signs of spalling (see Photos 25 through 28).

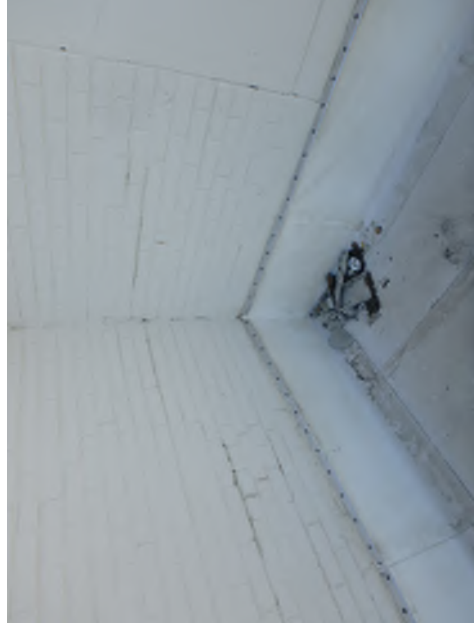
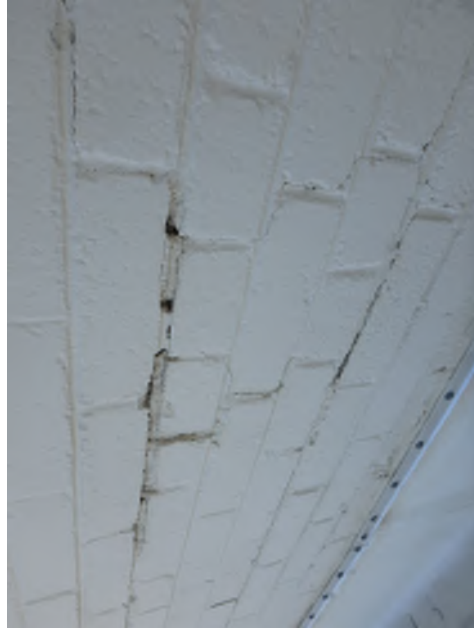
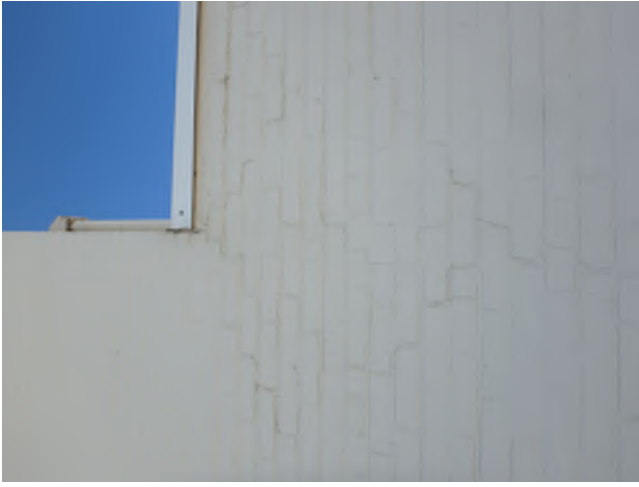
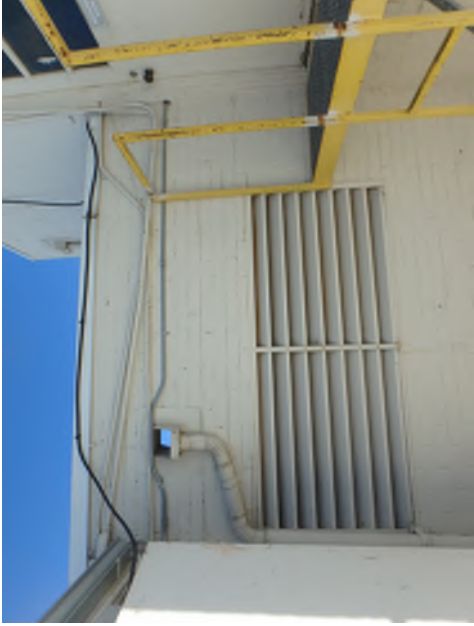
There are two small areas of painted brick at the elevator penthouse. There are multiple stair-step cracks throughout the mortar joints (see Photos 30 through 33) These cracks present a pathway for water ingress and should be addressed.

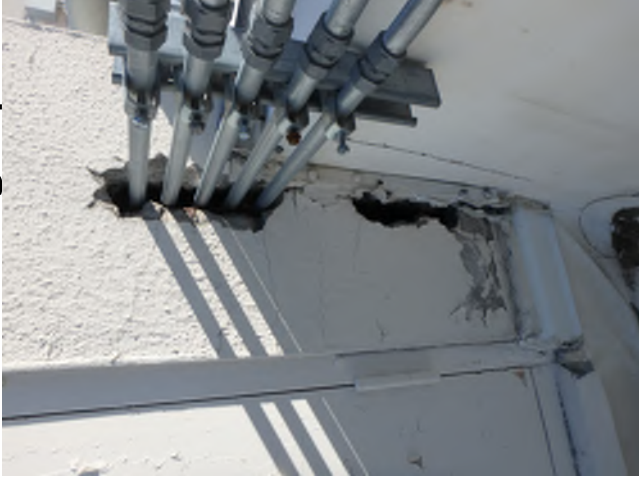
Photo 34

There are two mechanical penthouses and are clad with stucco. All are in fair to poor condition, with many cracks (see Photo 34), failed paint, and unsealed penetrations that have been roughly cut through the walls. These all present pathways for water ingress and should be addressed. Stucco of this vintage also largely relies on the exterior surface as the primary air and water control layer, and based on its condition it is not an effective air or water barrier.

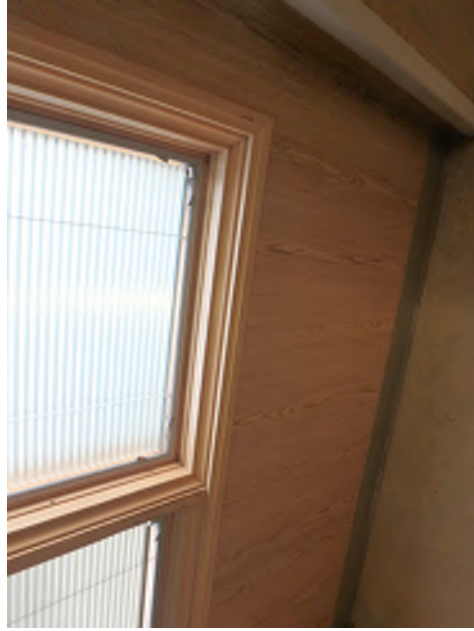
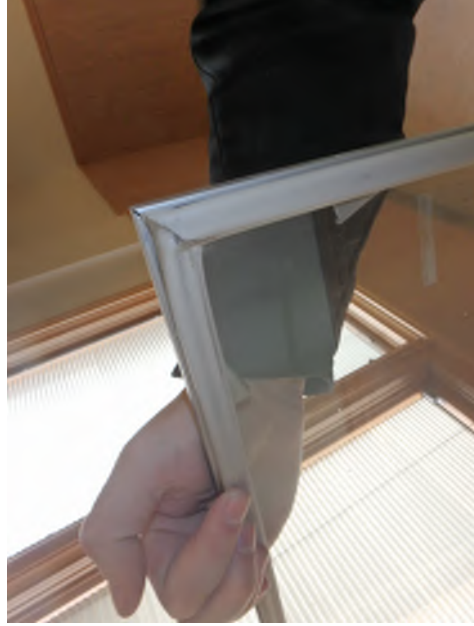
The clad wood windows include a removable interior pane of glass (see Photo 35 and 36), and therefore lack the more common sealed insulated glass unit (IGU) which is the norm for contemporary windows today. We found evidence of some condensation-related moisture staining on the wood frames (see Photo 37 and 38), but they are otherwise in fair condition.

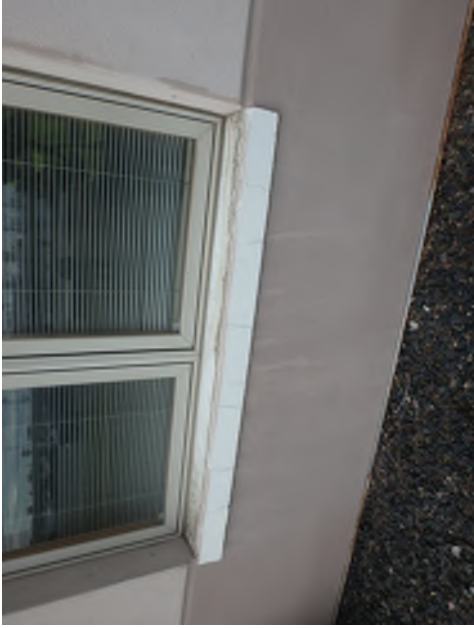
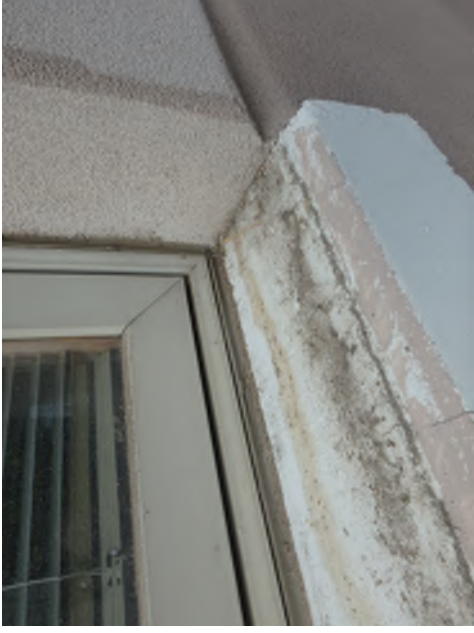
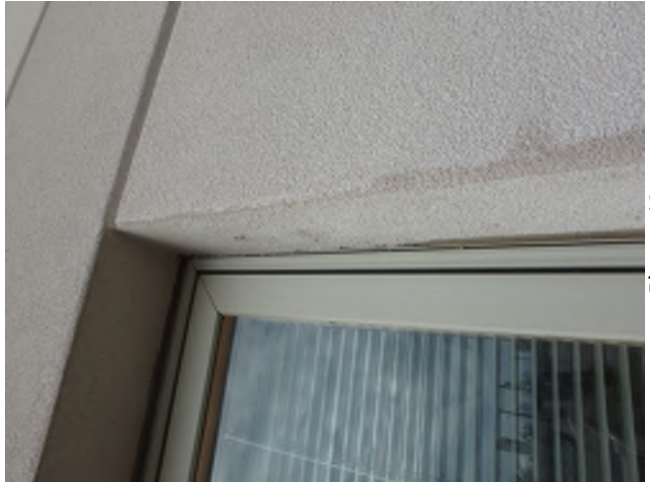
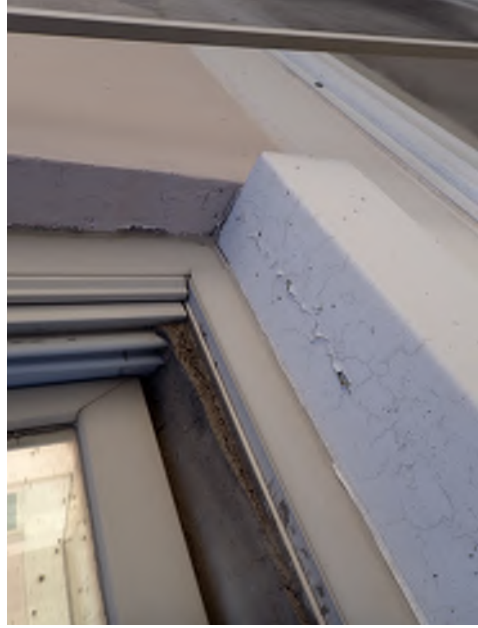
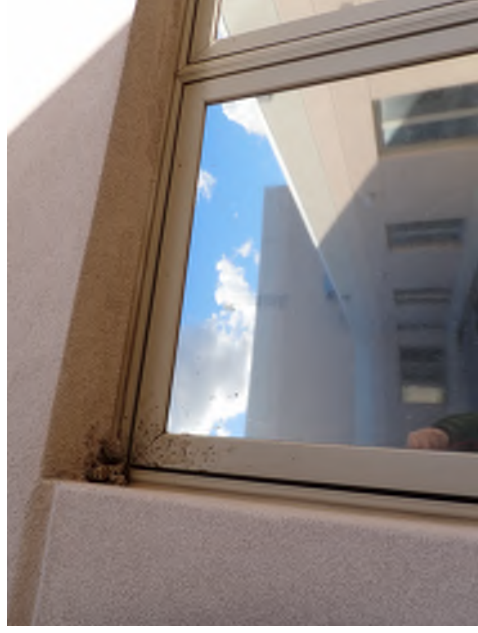
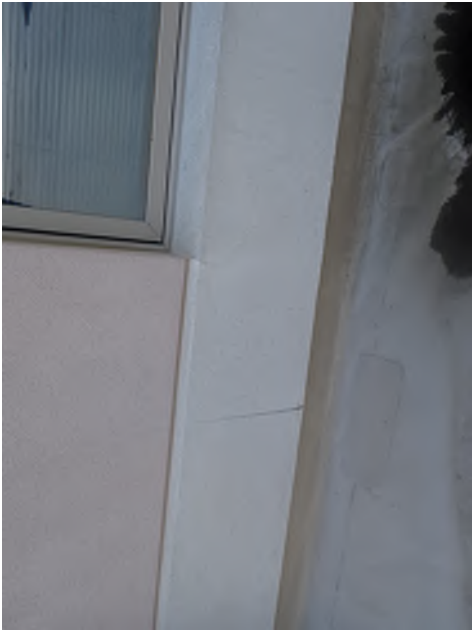
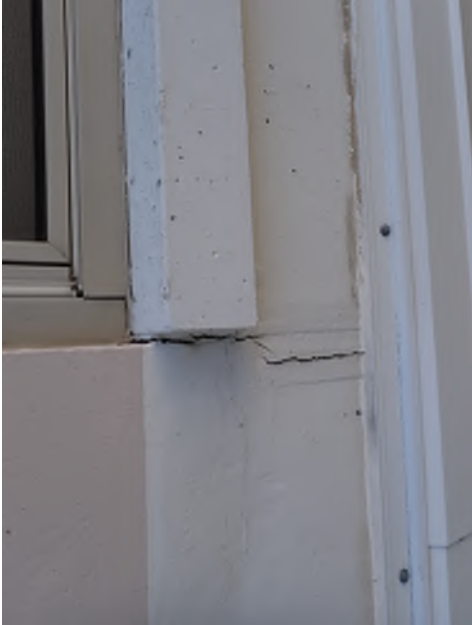
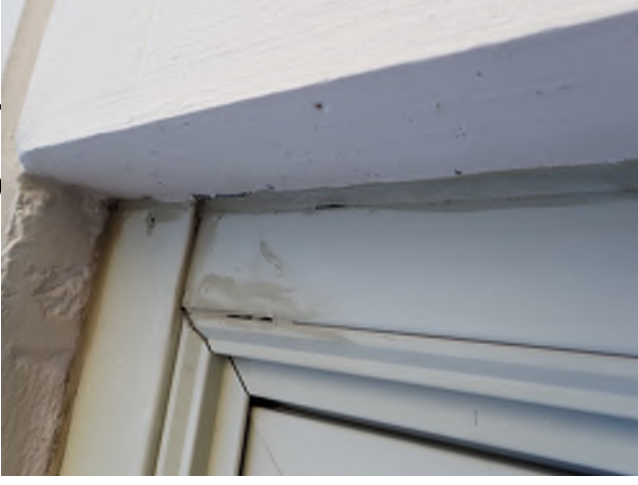
Exterior sealants between clad frames and adjacent EIFS are typically weathered and beginning to fail. Exterior sills at windows generally include painted precast concrete (see Photo 39 through 46), or a shallow EIFS return detail. Often this sill exhibits hairline cracks visible through the paint coating, or at the EIFS itself below the jambs of the window.

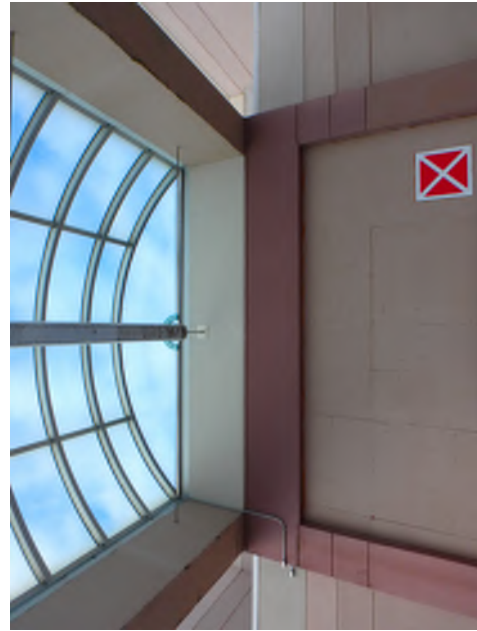
Photo 47

A section of sloped glazing occurs above the main entry driveway. This glazing consists of a barrel-style aluminum frame supporting glass units (see Photos 47 through 49). There are general signs of water ingress below the window frames at the EIFS-clad structure. We recommend planning to at minimum replace exterior seals between sections of glazing, and to improve the flashing detail at the EIFS-clad structure. As noted previously, the EIFS cladding at this structure should be replaced in order to address any concealed structural damage.

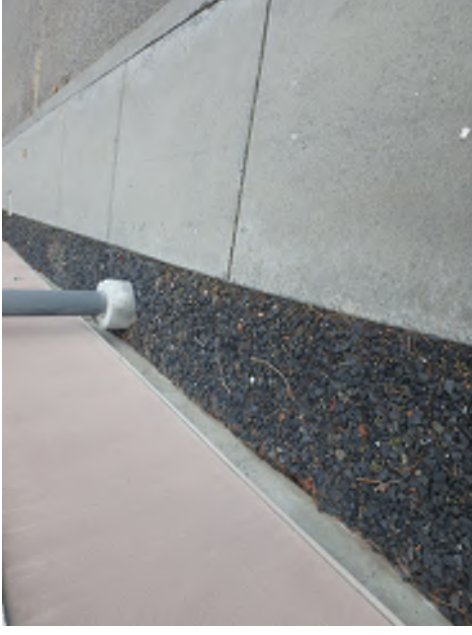
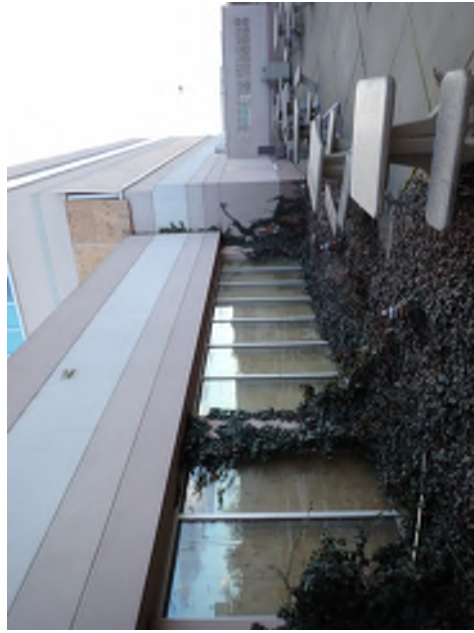
The typical at-grade condition around the building consists of a concrete sidewalk (see Photo 52 and 53). In various locations we documented signs of water-related damage near the base of the EIFS walls, and as such we recommend planning to remove portions of the EIFS around the base of wall areas in order to repair damage, add membranes, protective flashings, and improve the overall detail.

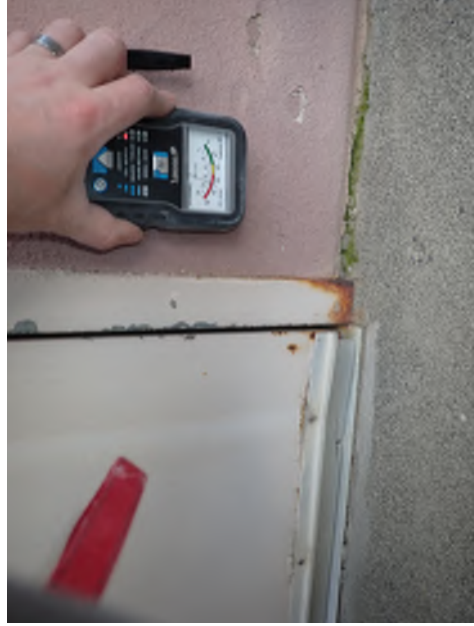
Photo 54

The majority of exterior doors are hollow metal frames with opaque hollow metal doors. Many of these doors are showing failed paint and significant corrosion, especially at the bottom of the doors (see Photo 54).

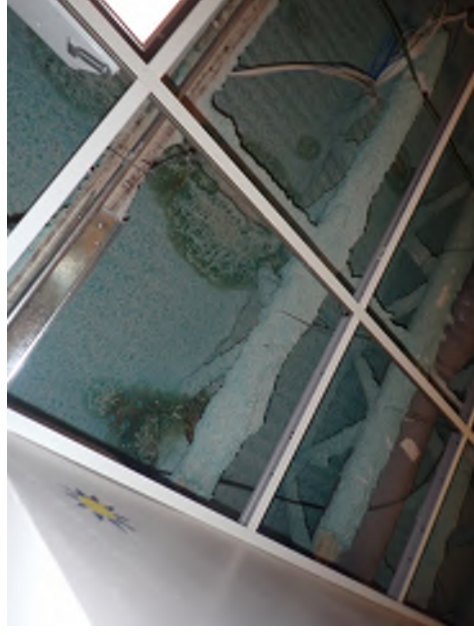
Photo 55

During the walkthrough of the interior 2nd floor, RDH was made aware of 4 active leak locations associated with the single-ply roof of Roof Area D and K (see Photos 55 through 58). While on-site, some repairs were performed by the building maintenance staff to puncture damaged areas of the PVC roof membrane.

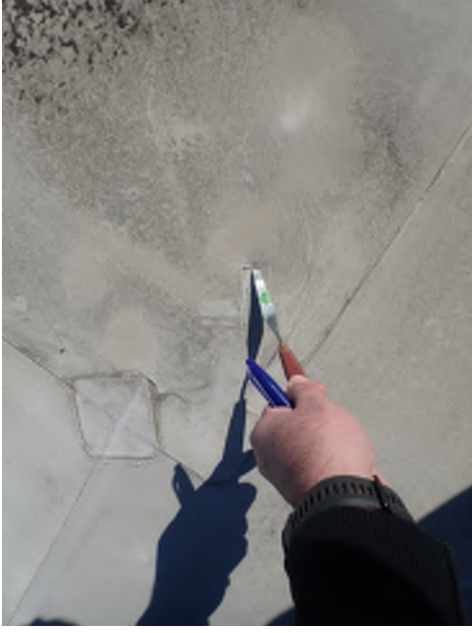
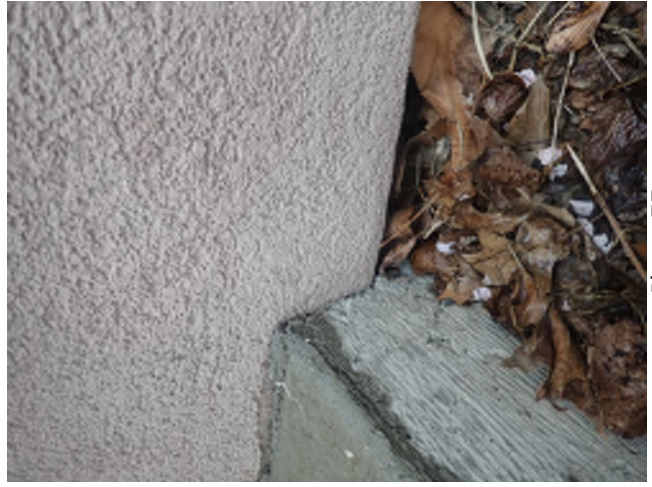
- There are multiple locations where the EIFS extends below the exterior grade or concrete sidewalks (Photos 77-78).
- There are sloped EIFS used at the SW corner of the Spaulding building over the terraces, the coating is failing at this location and there is significant signs of staining of the EIFS (Photo 79).
- Multiple failed sealant joints at inside corners (Photo 80).
- Cracking occurring at inside corners at SW corner terraces (Photo 81).
- At the SW corner L2 terrace when viewed into the soffit there are signs of leaks at the base of the exterior wall above the soffit (Photo 82).

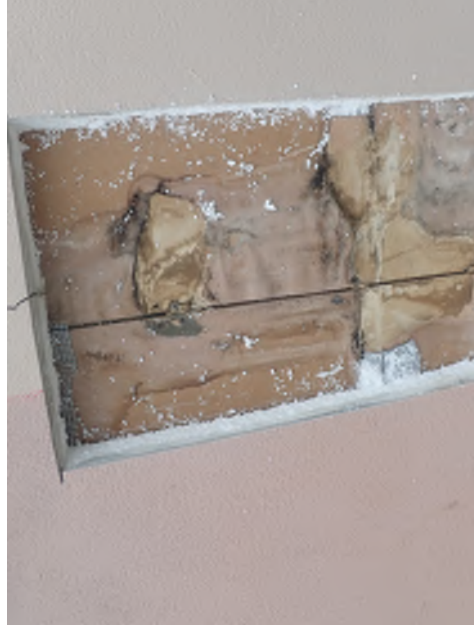
Photo 85

The roof system components at this location are in fair to poor condition (Photo 85).

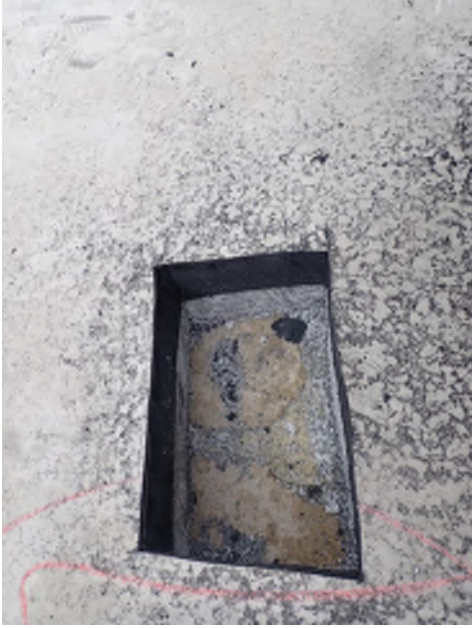
Photo 88

The roof system components at this location are in fair to poor condition (Photo 88).

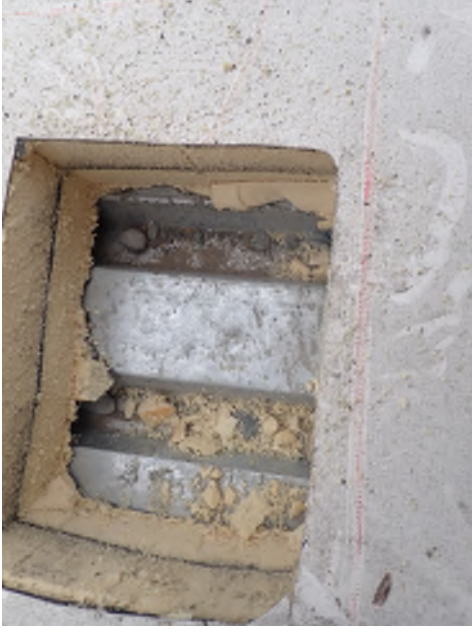
Photo 89

The roof system components at this location are in poor condition (Photo 89).

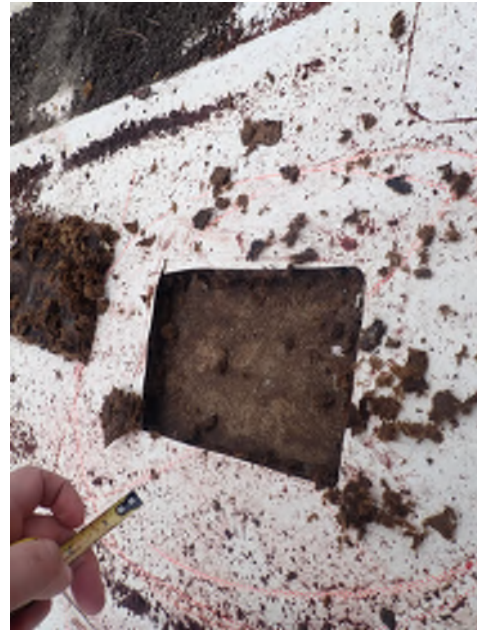
Photo 90

The roof system components at this location are in fair to poor condition (Photo 90).

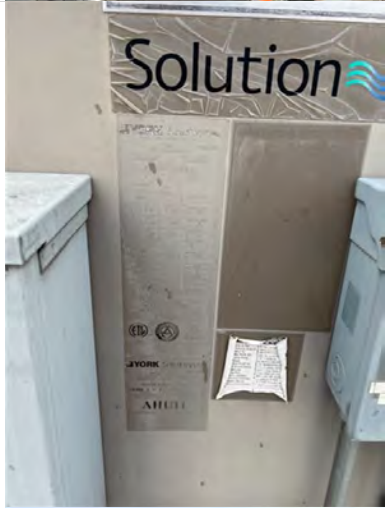
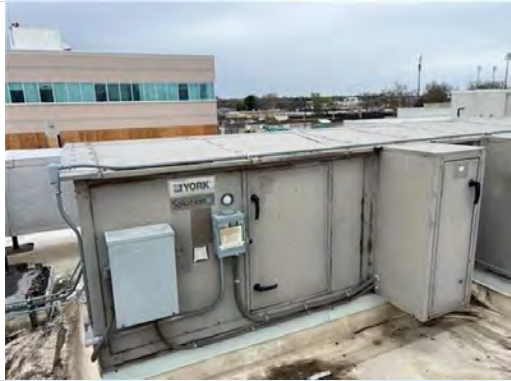
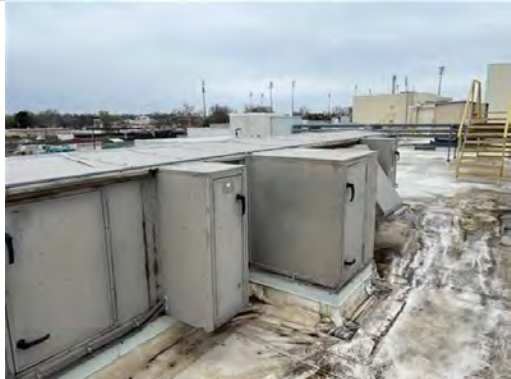
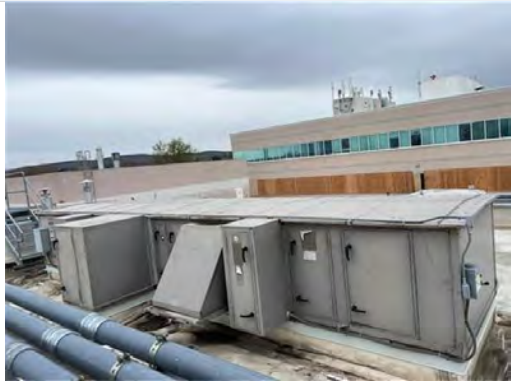
Unit	Description	Picture
AHU-13	<p>System age is 16 years. This is nearing the end of the useful life expectancy of 20 years.</p> <p>System Condition: Poor</p>

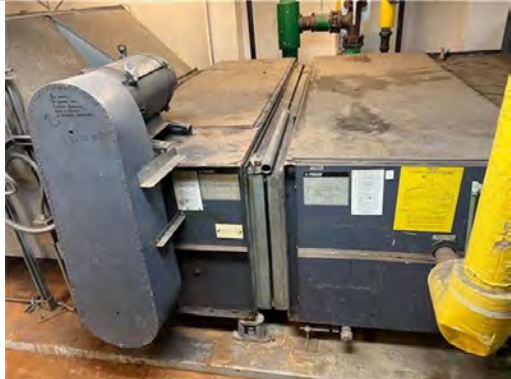
AHU-14	<p>System age is 33 years. This exceeds useful life expectancy of 20 years.</p> <p>System Condition: Poor</p>

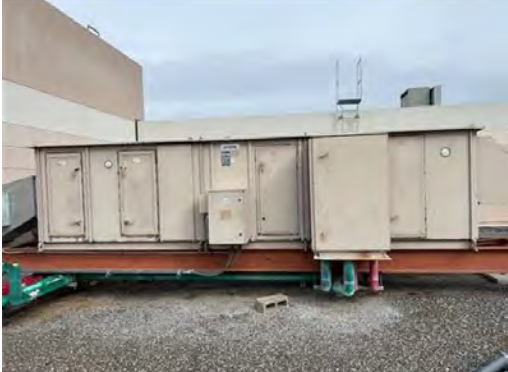
AHU-15	<p>System age is 17 years. This is nearing the end of the useful life expectancy of 20 years.</p> <p>System Condition: Poor</p>

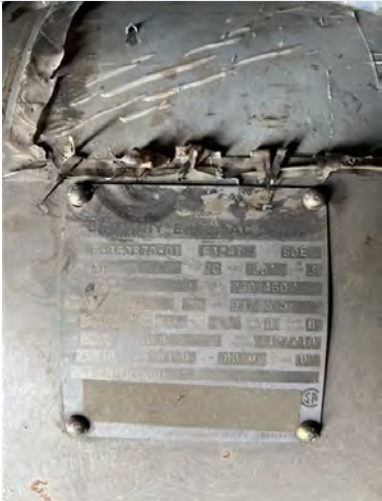
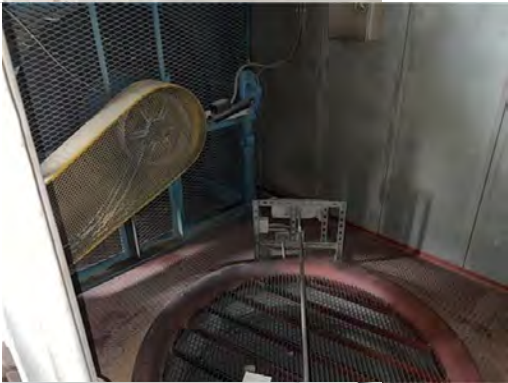
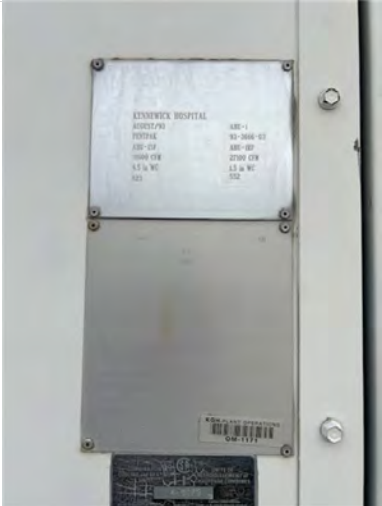
Unit	Description	Picture
AHU-19

Unit	Description	Picture
AHU-16	<p>System age is 12 years. This is nearing the end of the useful life expectancy of 20 years.</p> <p>System Condition: Poor</p>	
AHU-16		
AHU-19	<p>System age is 27 years. This exceeds useful life expectancy of 20 years.</p> <p>System Condition: Poor</p>

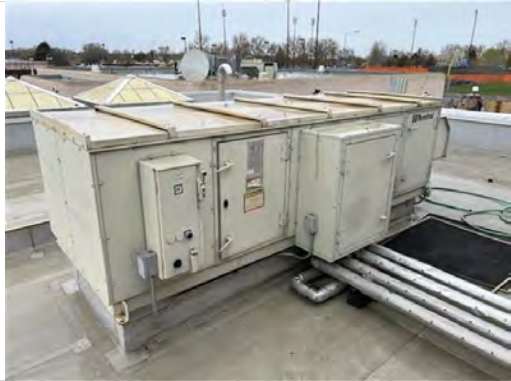
AHU-U2	<p>System age is ?? years.</p> <p>Useful Life Expectancy: 20 years</p> <p>System Condition: Poor</p>

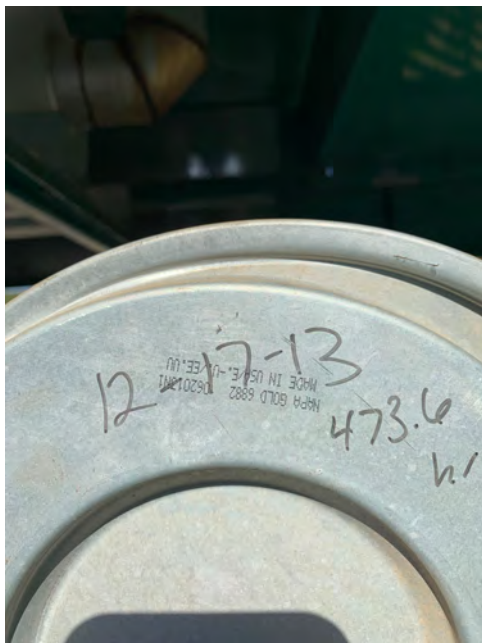
- 3.11 CHECK INTAKE AIR FILTERS / DOCUMENT PART NUMBERS PASS

Comments: Recommend replacement

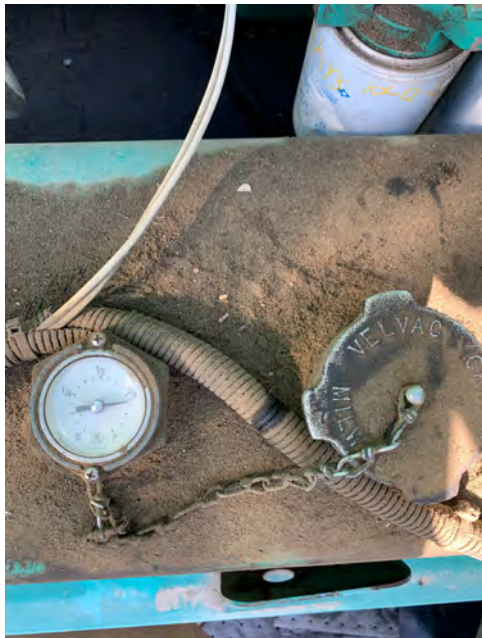
● 6.1 FUEL SYSTEM TYPE / TANK LEVEL / CAPACITY PASS

Comments: Diesel
3/4 full

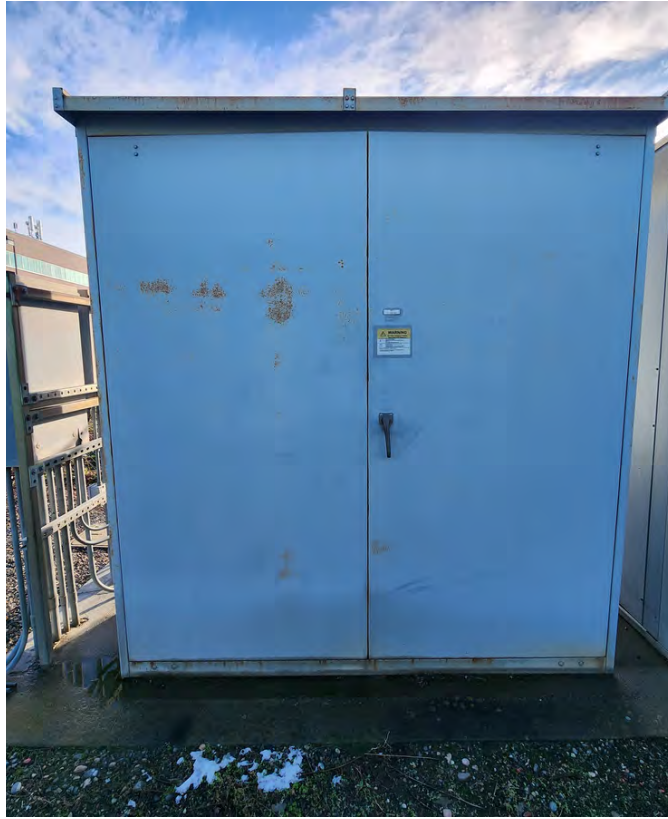
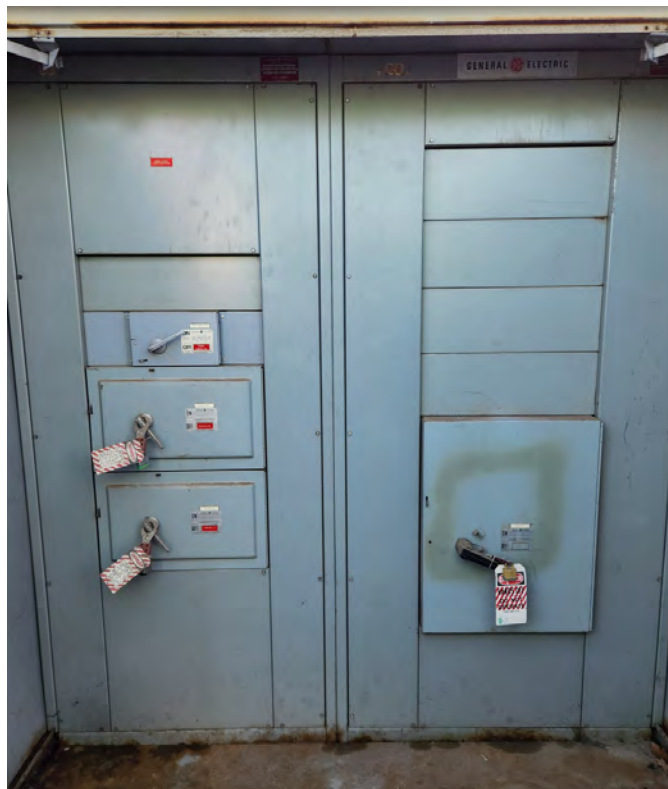
PDP-1 800A (277/480V) Only feeding
lea 30A trash compactor load

- Service 3 480/277V, 800A (if utilized) will require new service disconnect due to code issues with existing installation.
- Service 1 480/277V, in the equipment yard (if utilized), will require replacement of PDP-1 gear due to condition and code constraints.
- Service 2, 208/120V, anticipated to be utilized and feeds the panelboards found in the currently planned program space. Water issues will need to be resolved in the penthouse electrical room.
- Service 4 (Spalding) program space not anticipated to be in Spalding. No issues with distribution equipment observed.

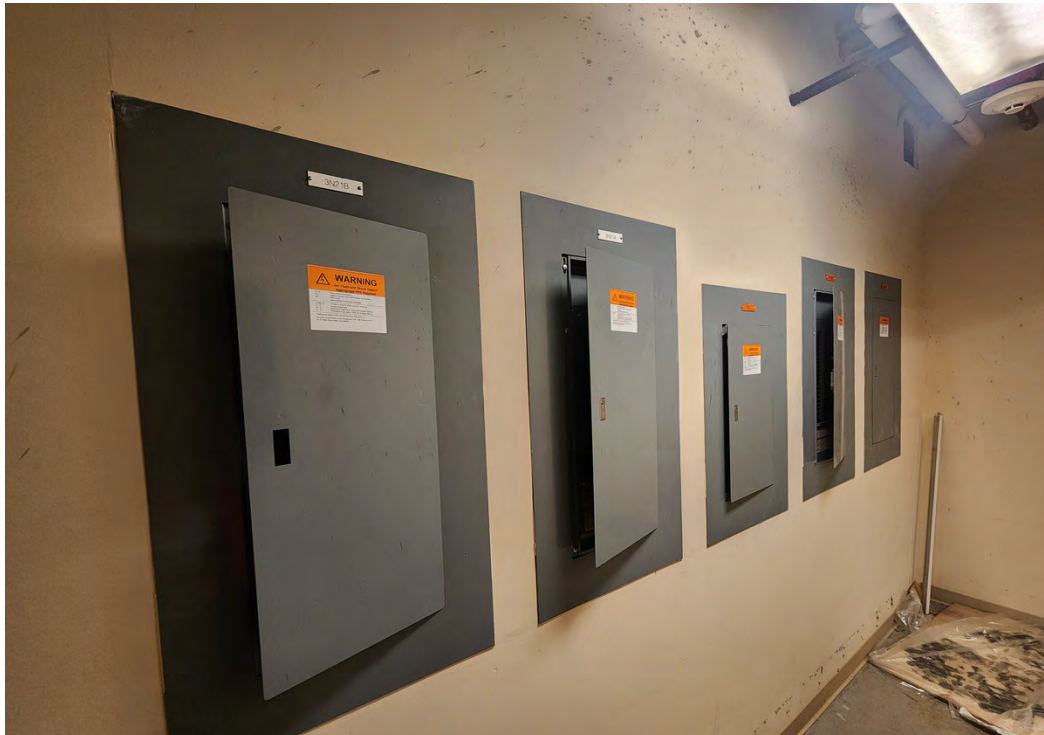
Family Birthing Electric Room (Main floor, exterior access)

Would need to cover these panels to normal power, but lots of capacity

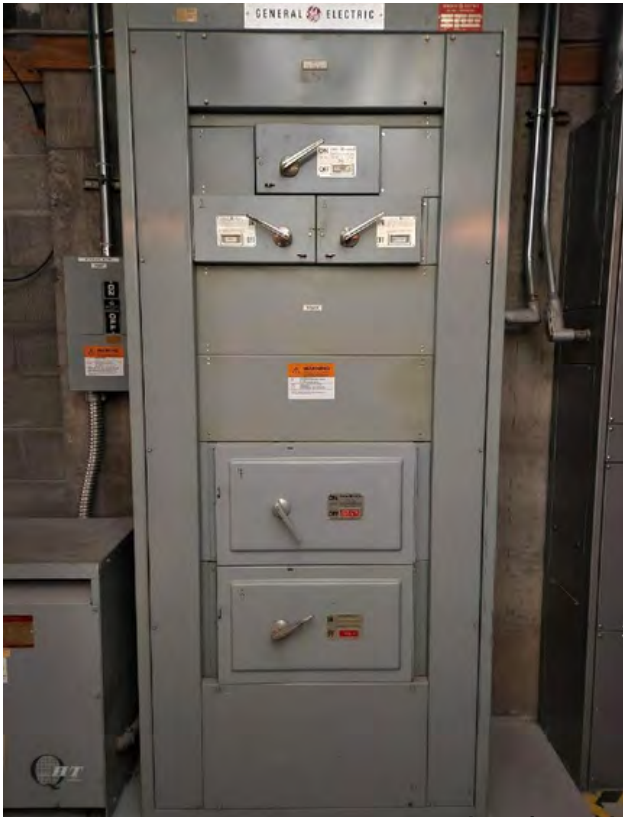
PDP-2 600A (277/480V)

Could use for new mechanical loads

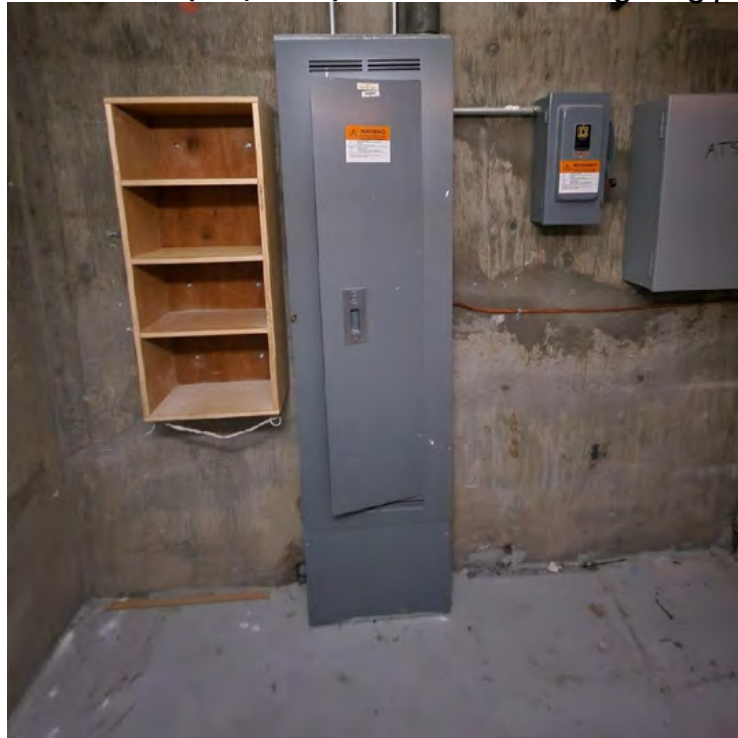
PDP-3 225A (277/480V) Could use as our lighting panel

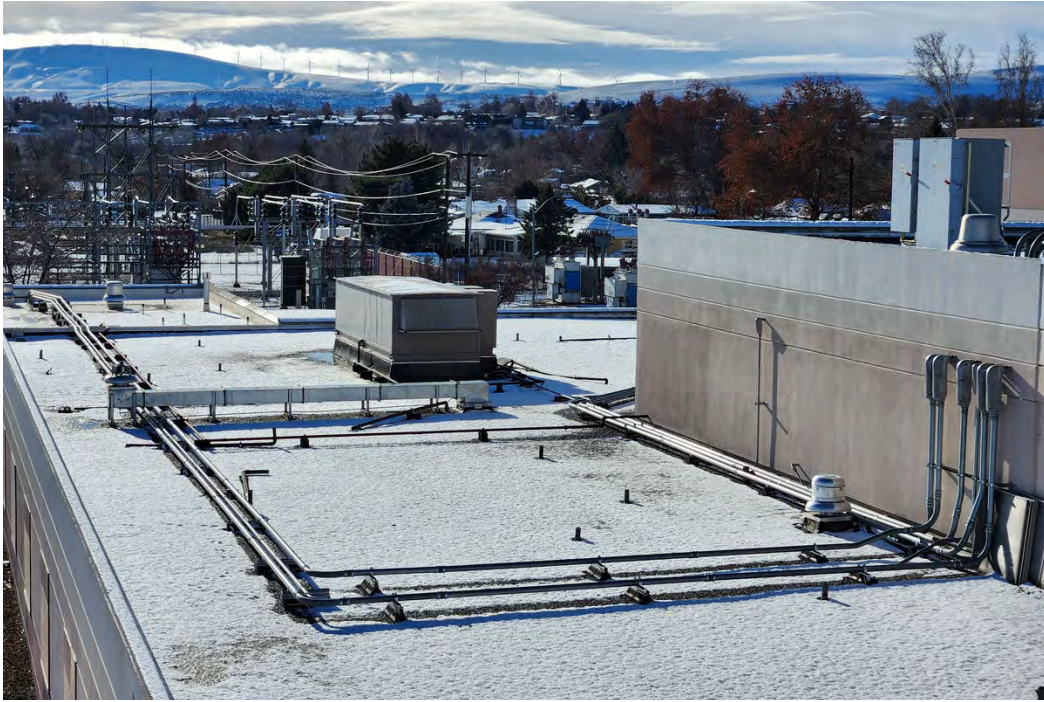
Family Birthing Electric Room Conduit Installation. All conduit installed on the roof will remain as is.

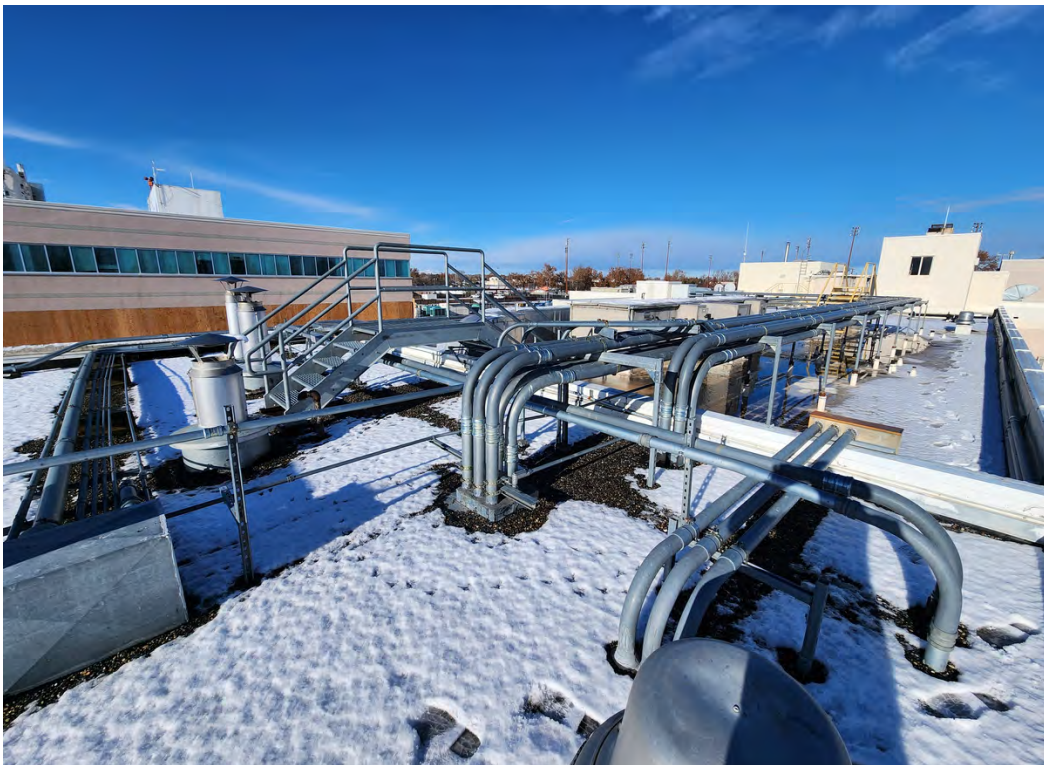
Electrical Room #2 Conduit Installation. All conduit installed on the roof will remain as is.

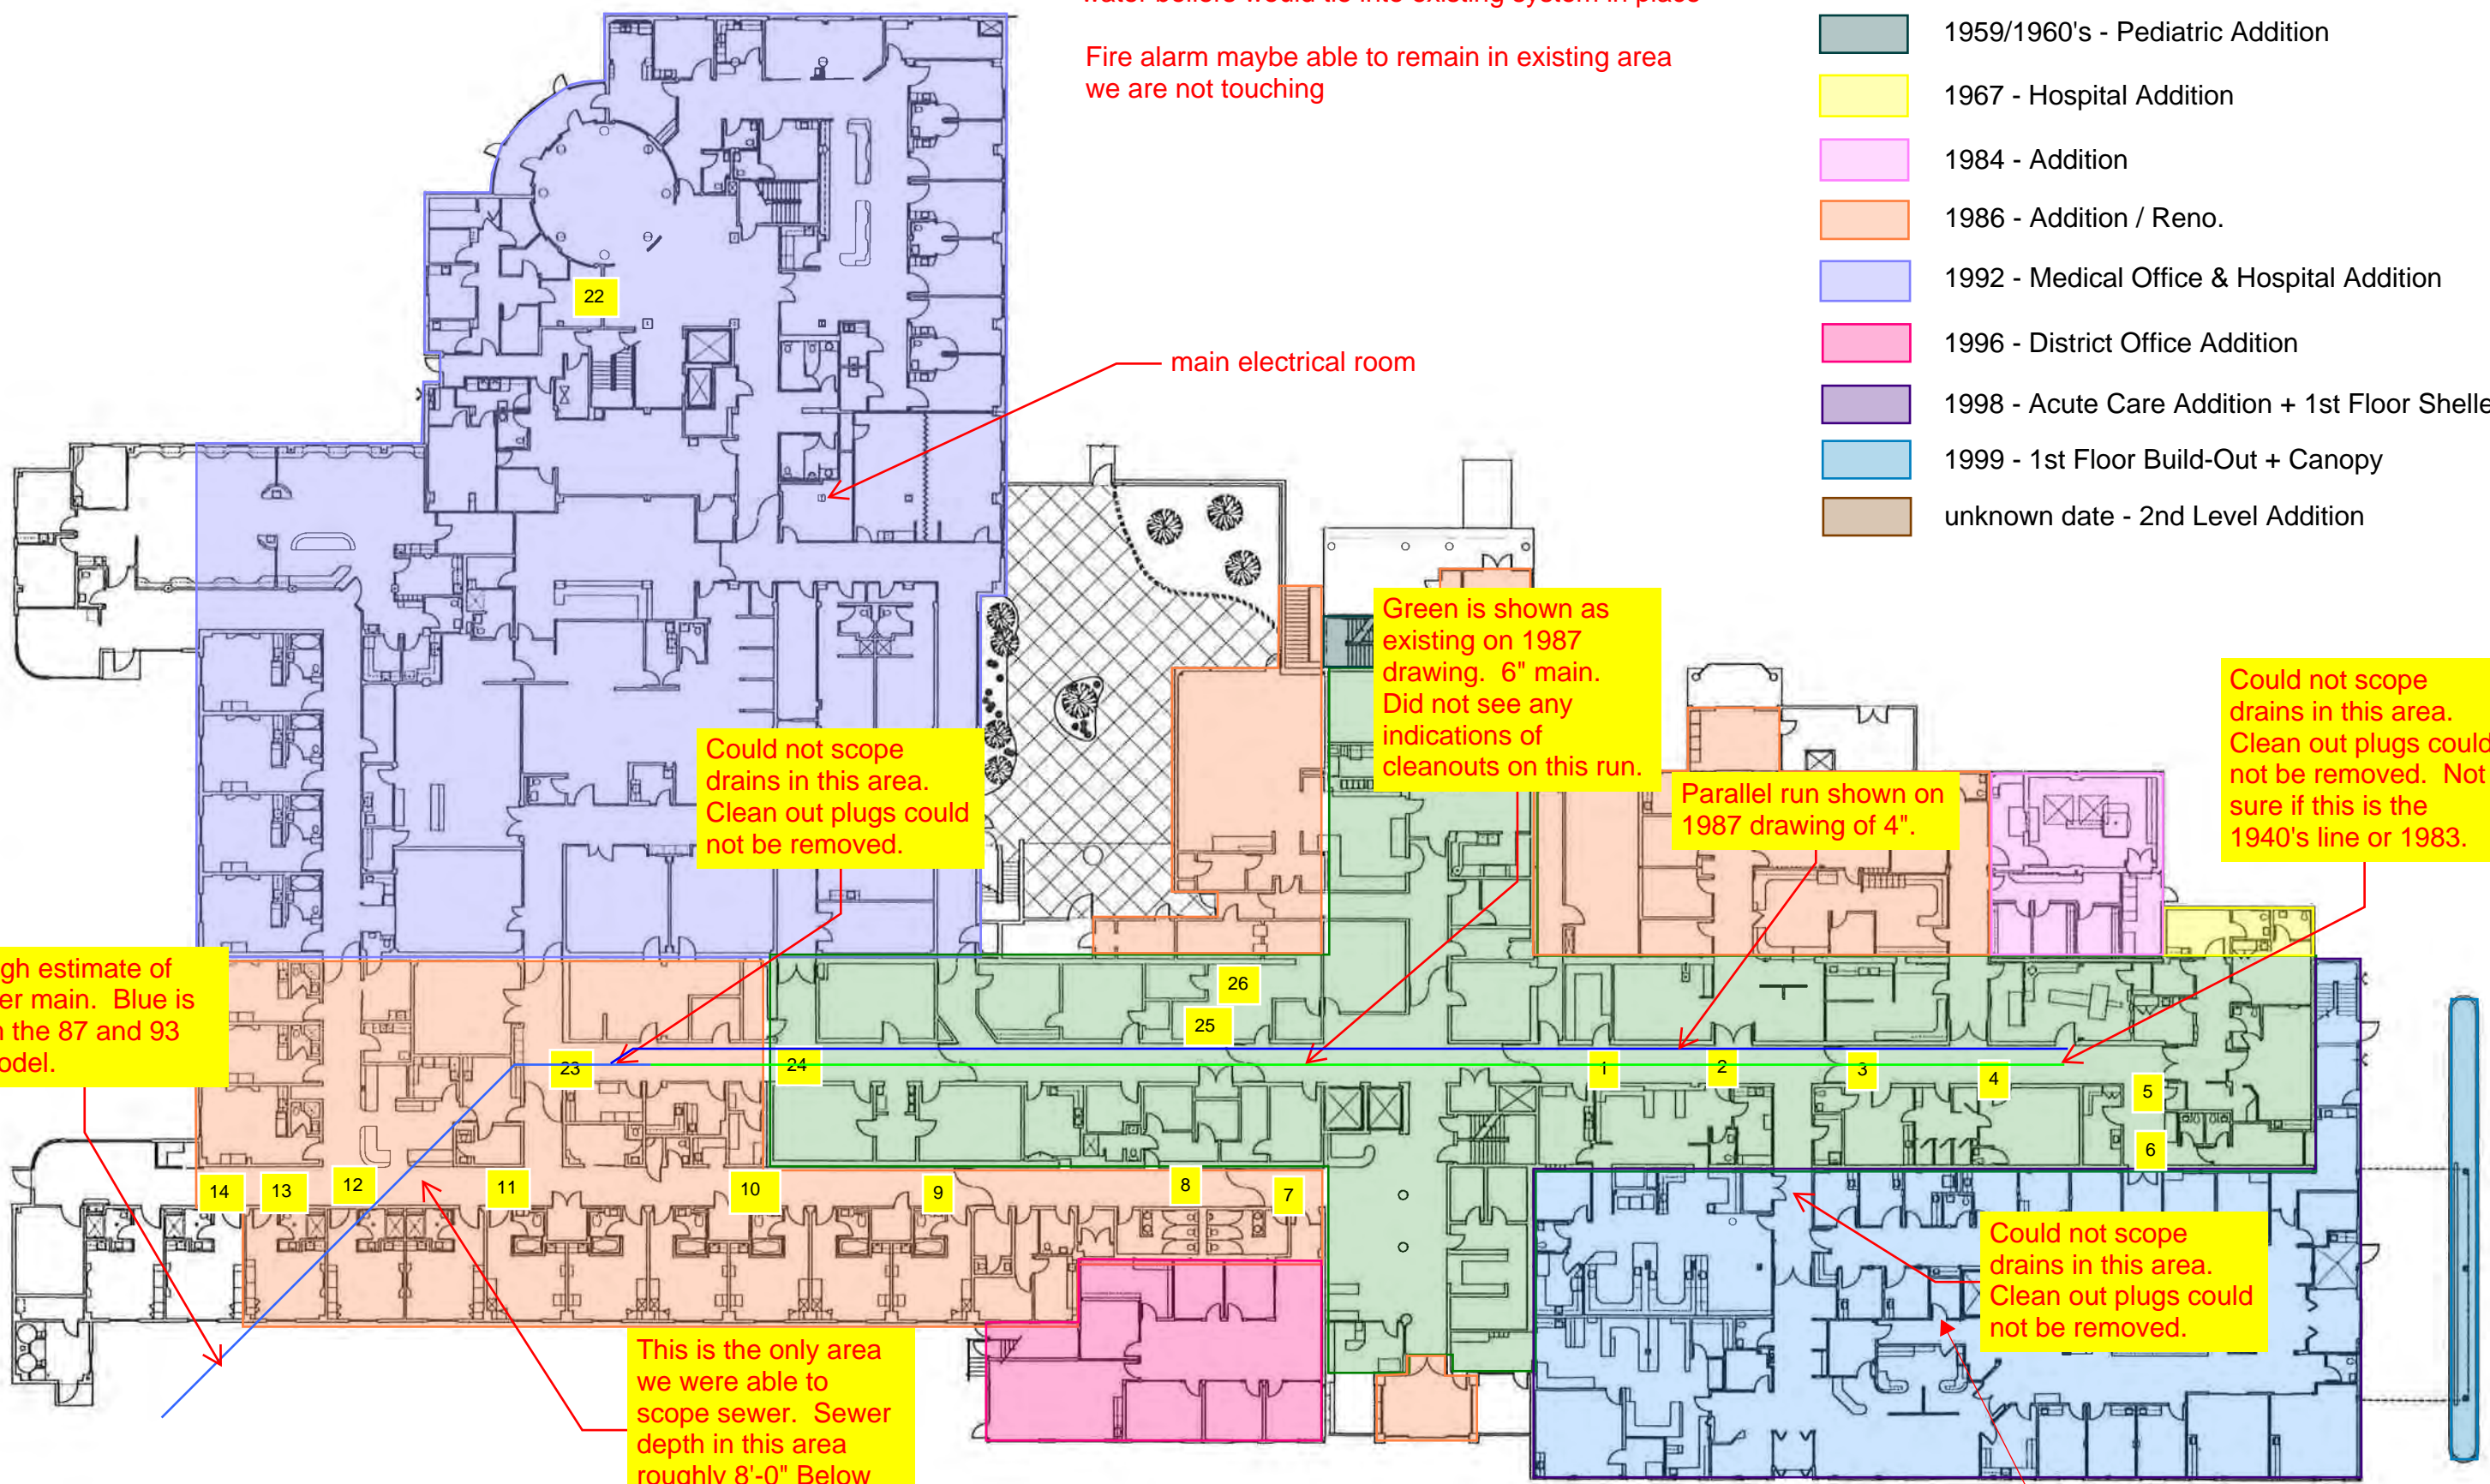
Could not scope drains in this area. Clean out plugs could not be removed.

Green is shown as existing on 1987 drawing. 6" main. Did not see any indications of cleanouts on this run.

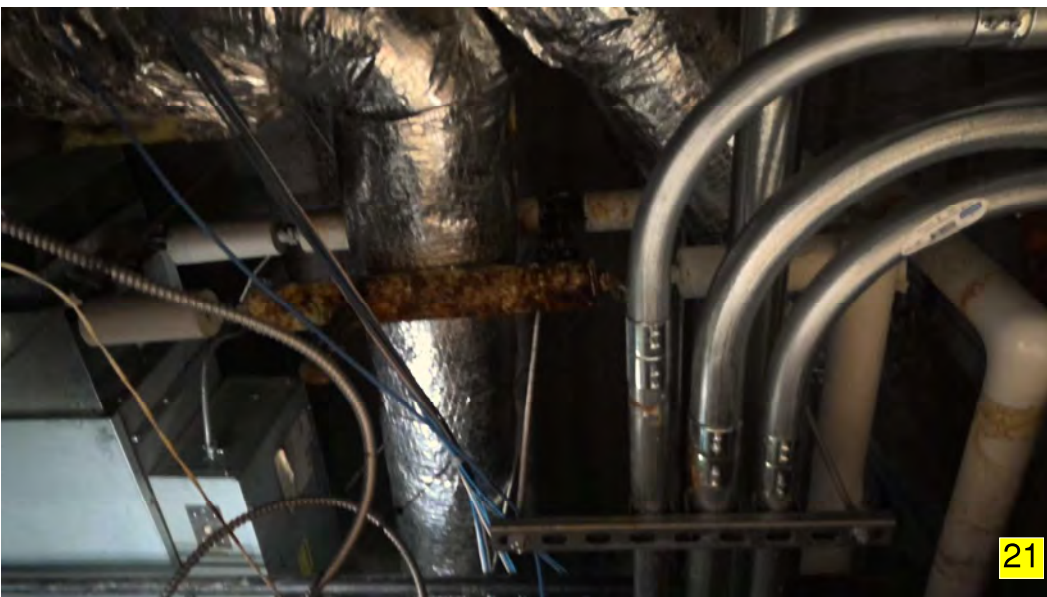
20	Existing steam generator indicating the age of the equipment, past its life expectancy.
21	Leaking pipe and causing corrosion. Needs replaced.
22	Dissimilar metals causing electrolysis. Failure point in pipe.
23	Broken black pipe of hydronic system. Shows corrosion and failure of pipe.
24	Dissimilar metals and old waste lines that needs replaced.
25	Dissimilar metals and old waste lines that needs replaced.
